ADVANCED RESEARCH AND APPLICATIONS CORP SUNNYVALE CA
IMPROVEMENT IN GAAS DEVICE YIELD AND PERFORMANCE THROUGH SUBSTR--ETC(U)
OCT 78 T J MAGEE, J PENG, J HONG

IMPROVEMENT IN GaAs DEVICE YIELD AND PERFORMANCE
THROUGH SUBSTRATE DEFECT GETTERING

REPORT DOCUMENTATION PAGE		READ INSTRUCTIONS BEFORE COMPLETING FORM	
1. REPORT NUMBER	2. GOVT ACCESSION NO.	3. RECIPIENT'S CATALOG NUMBER	
4. TITLE (and Subtitle) Improvement in GaAs Device Yield and Performance Through Substrate Defect Gettering		5. TYPE OF REPORT & PERIOD COVERED 6 Month Technical Report

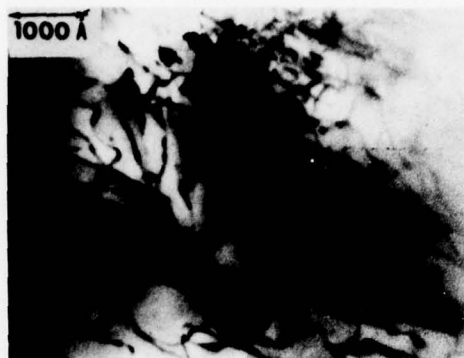
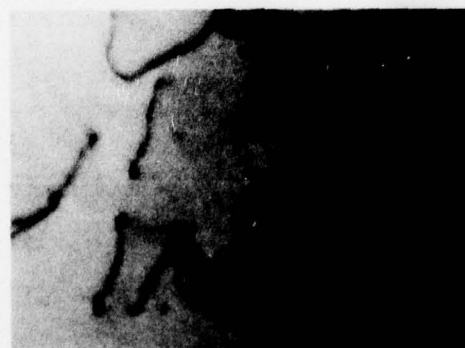
FIGURE 6. BRIGHT FIELD ELECTRON MICROGRAPHS OF SECTIONED WAFERS SHOWING DAMAGE AT DEPTH ($60\text{ }\mu\text{m}$ ABRASIVE PARTICLES); a) $d = 1000\text{ }\text{\AA}$; b) $d = 7500\text{ }\text{\AA}$; c) $d = 10.2\text{ }\mu\text{m}$.

In sharp contrast to earlier studies and to practices currently used by manufacturers in back-surface damage of Si wafers, we found that assessments of the concentration of microscopic damage introduced into the GaAs substrate cannot be characterized by the depth or distribution of macroscopic grooves and/or pits produced at the back surface. TEM analysis must be used routinely in these applications to identify the distribution of microstructural defects. In Figures 3 through 6, transmission electron micrographs show the distribution of damage at various depths for samples subjected to rotary abrasion at 8000 rpm for 30 sec at a vertical stage pressure of 47 psi, using particle sizes of 0.3 μm , 12.5 μm , 30 μm and 60 μm , respectively. In all cases, we observe a distribution of microstructural damage extending beneath the region of mass removal and macroscopic grooving. Hence, the experimental conditions used produce a laterally continuous sheet of dislocation lines in forested arrays and tangles that extend to a maximum observable depth of 1.5 μm below the depth of grooves at the back surfaces. In Figures 3 - 6, we observe that the maximum near-surface concentration is produced for the larger particle sizes. In addition, the density of dislocation lines decreases rapidly as a function of depth for the smaller particle sizes. In all samples examined, we detected no dislocation line structure at depths exceeding 1.5 μm .

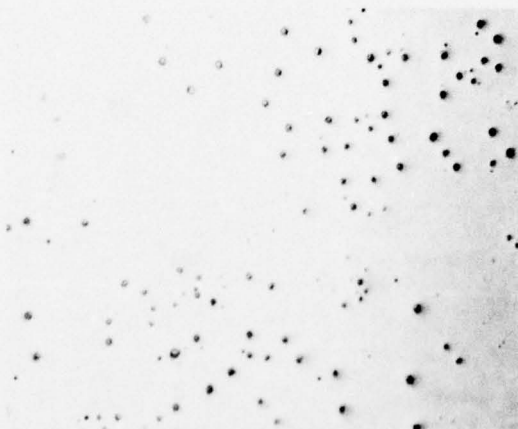
FIGURE 13. OPTICAL MICROGRAPHS SHOWING DEFECTS AT THE SURFACES OF CONTROL (UNANNEALED) AND ANNEALED Si_3N_4 CAPPED SAMPLES; a) Control; b) Annealed.

We next prepared two sets of samples from the Si_3N_4 capped wafer provided by Avantek. In the first set of samples, the nitride layers were removed from the substrate by immersing the structure in a dilute HF solution. The remaining samples were first annealed at 800°C for 30 min in H_2 and the cap subsequently removed in HF. All samples were then immersed in a standard $\text{H}_2\text{SO}_4:\text{H}_2\text{O}_2:\text{H}_2\text{O}$ (3:1:1) solution to expose defects or etch features on the (100) surface. Figure 13 shows representative optical micrographs of control and annealed sample surfaces after etching. Comparing Figure 13a) (control) and Figure 13b) (capped, annealed), we observe a slight reduction in the surface defect density, indicating a small apparent reduction in surface defect concentration. We then repeated the experiments on several sets of samples with essentially identical results, thereby supporting the contention that the encapsulant may exercise a small, but perceptible, defect gettering effect.
